**EVALUATION OF THE EFFECTS OF A PLASTIC BEAD  
PAINT REMOVAL PROCESS ON PROPERTIES OF  
AIRCRAFT STRUCTURAL MATERIALS**

Materials Integrity Branch  
Systems Support Division

December 1985

Final Report for Period October 1984 to August 1985.

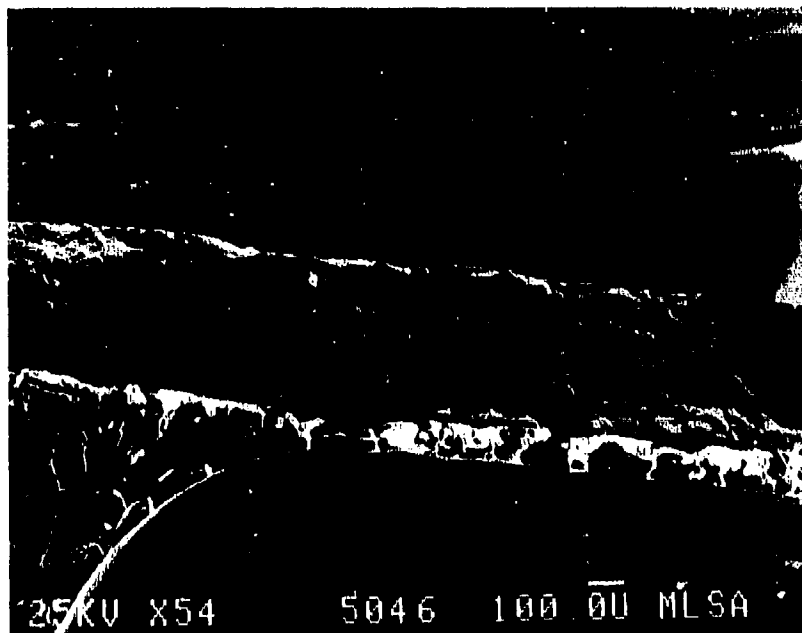
First, the fatigue crack initiation sites were located either on the plastic bead blasted side, at the corner, or at the edge of the fatigue specimen. Sometimes the specimens failed in the taper radius between the grip and the gage section. Failures in the radius typically initiated at the specimen edge or corner. Regardless of the location of the initiation site, the sites were readily detected optically using low magnifications (2x to 7x). Typical initiation sites as they appeared in the electron microscope are shown at higher magnifications in Figures 19 and 20. Crack initiation sites located on the plastic bead blasted surface were scrutinized while those initiation sites located on the edge or corner received little attention; edge and corner initiation sites are mechanistically favored when compared to surface sites for the specimen configuration used in this program. In order to determine whether or not plastic bead paint stripping effected the fatigue life, only those fatigue initiation sites located on the plastic bead blasted surface could be construed as responsible for affecting the fatigue life. Fractography also revealed that none of the crack initiation sites were located on the honeycomb side of the panel.

Figure 19. Typical Surface Initiation Site of an Alclad 7075-T6 Alloy. Specimen 17A, first paint removal at 38 psi. MAG: (a) 54X, (b) 200X

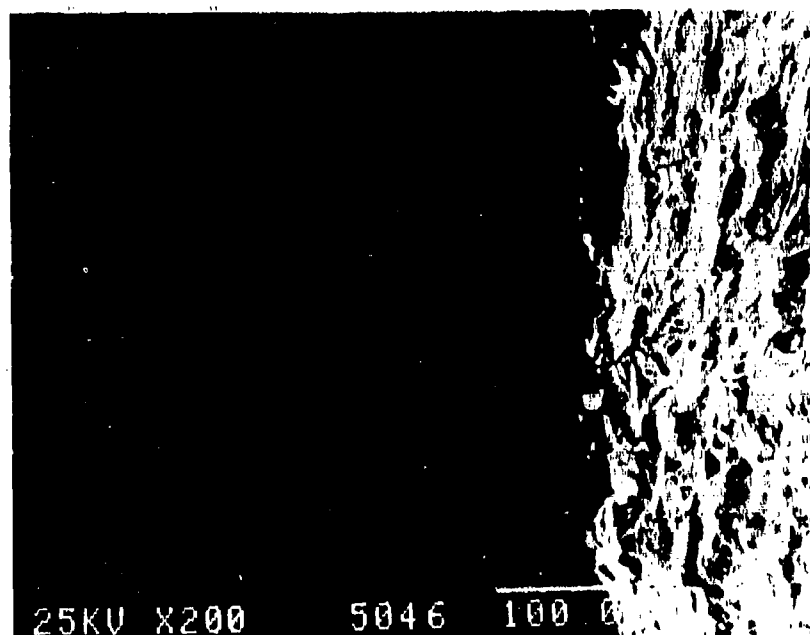
Figure 20. Oblique Fractograph of Specimen 17A; Left Side of Picture (Dark Surface) Is the Stripped Surface; Right Side (Light Surface) Is the Fracture Face. Note the fracture initiated on the stripped surface and the silica particle embedded in the initiation site. MAG: 200X

The second common feature detected by fractography was the texturing of the clad surface by the plastic bead paint removal. The left side of Figure 20 is an excellent example of this texturing. Since 7072 cladding is very soft it was either stripped off or smeared around the surface of the panel during plastic bead paint removal. This effect was confirmed by the metallographic cross sections described and depicted earlier in this report. In some cases, this texturing effect was very extensive and in other cases the effect was minimal. The most critical case for fatigue is when the texturing creates initiation sites, and for protection against corrosion the most critical case is when the blasting removes the cladding. It is important to understand the implications of damaging the cladding by plastic bead paint removal. The first implication is obvious: protection against corrosion offered by the cladding is reduced. Secondly, since the 7072 cladding is metallurgically bonded to the 7075 core, any damage to the cladding, such as pitting, scoring or cracking, can serve as crack initiation sites. Once these sites are introduced into the cladding, a crack can grow into the core material. Therefore, one could conclude that plastic bead paint removal creates surface defects in the soft 7072 cladding which serve as both crack initiation sites and coating defects.

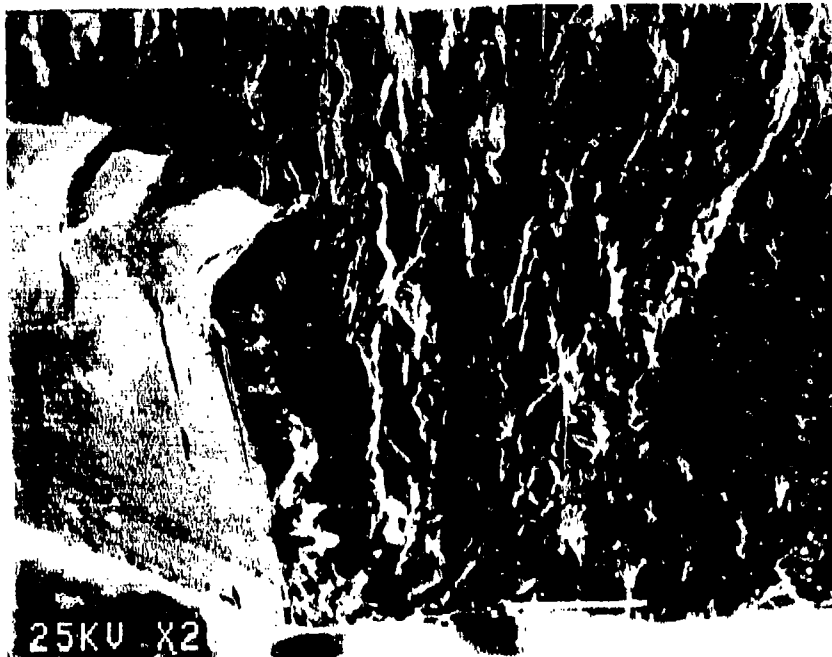
Figure 22 shows a corner initiation site with a lip which was created during specimen machining. After these lips were detected in the test program, they

Figure 22. Corner Fatigue Initiation Site on Specimen 50A. The fold was accidentally produced specimen machining and resulted in some premature failures. MAG: 200X

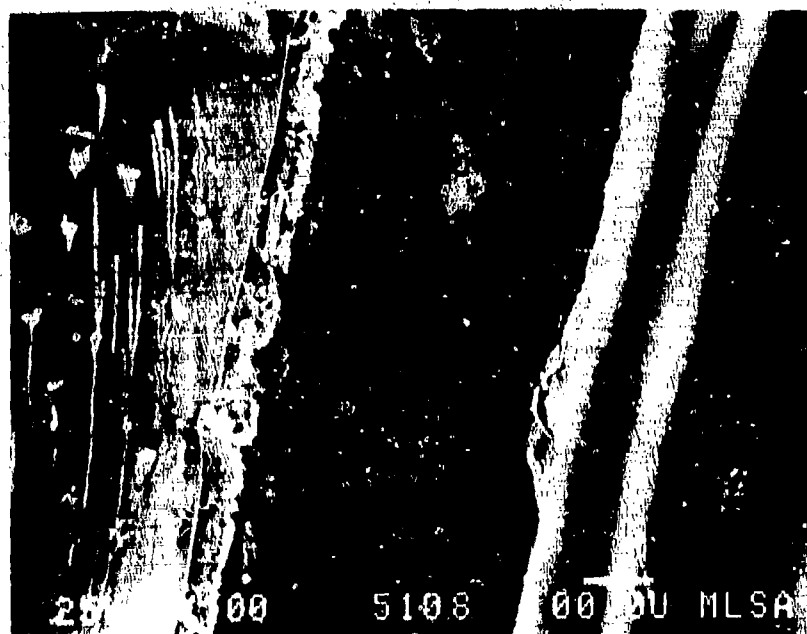
Figure 23. Initiation Site on Specimen 24B (Third Paint Removal at 38 psi).  
Note initiation site is near a surface defect. MAG: 100X

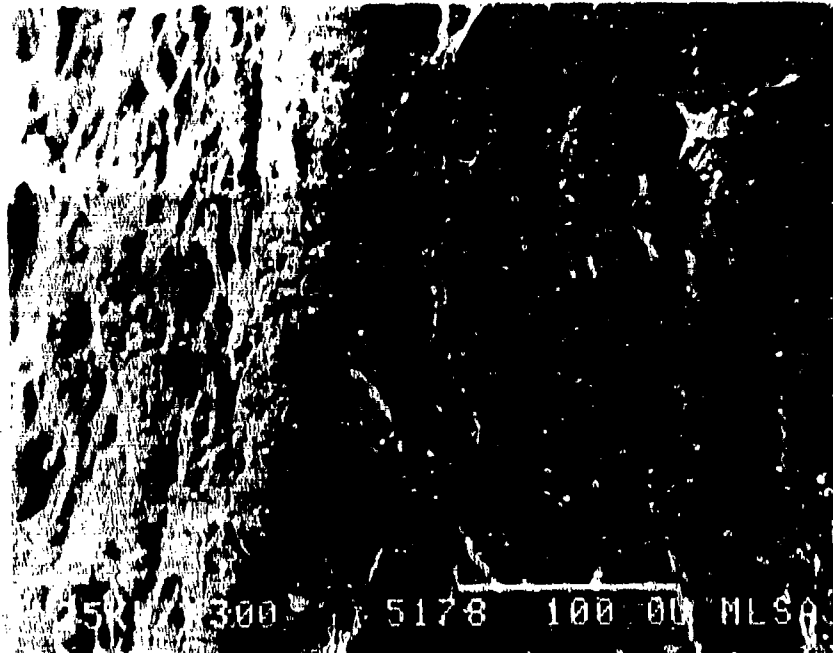
Figure 24. Fractographs Representative of the Fourth Paint Removal; (a) Specimen 67B; 38 psi; (b) Specimen 48B, 60 psi. Note the initiation site is a surface defect. MAG: (a) 300X, (b) 200X

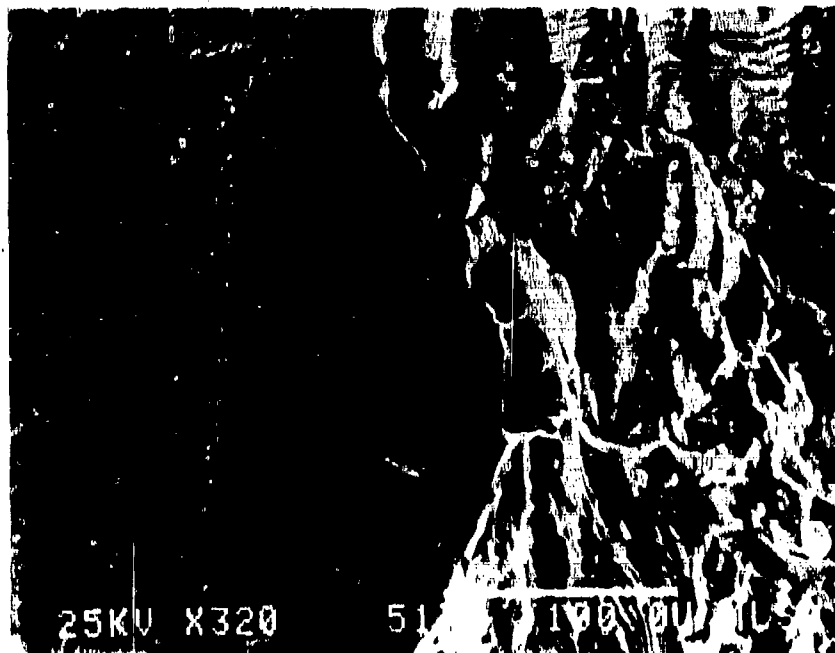
Figure 25. Fractograph of Specimen 36A (Five Coats of Paint/One Paint Removal). Initiation site is a surface defect. MAG: 320X
